Re: Old Town Hall Building – Structural Assessment
1 Milton O Fountain Way
Warren MA 01083

This letter is a structural assessment of the Old Town Hall building located at 1 Milton O Fountain Way and addresses the Foundation, Masonry Walls, Floors, Roof and the Clock Tower. Attached to this letter are captioned photos, cost estimates for the building renovation per current code to the former use group of each floor, being Business use on the first floor and Assembly use for the public on the second floor, as requested an estimate for the demolition of the building is included on the last page.

Structural Assessment:

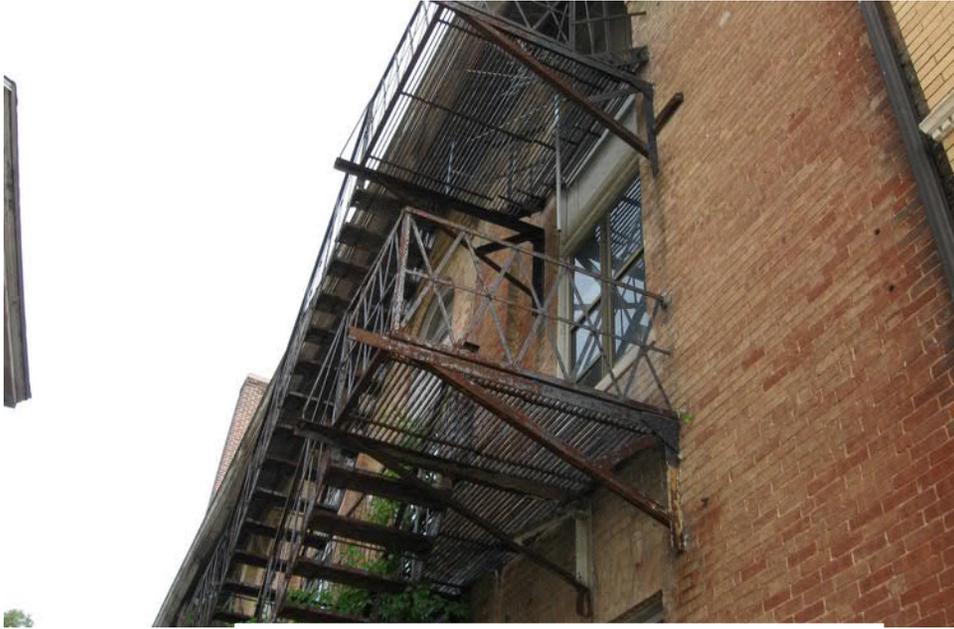
Fire Escape From Balcony - Poor Condition
IMG_2723

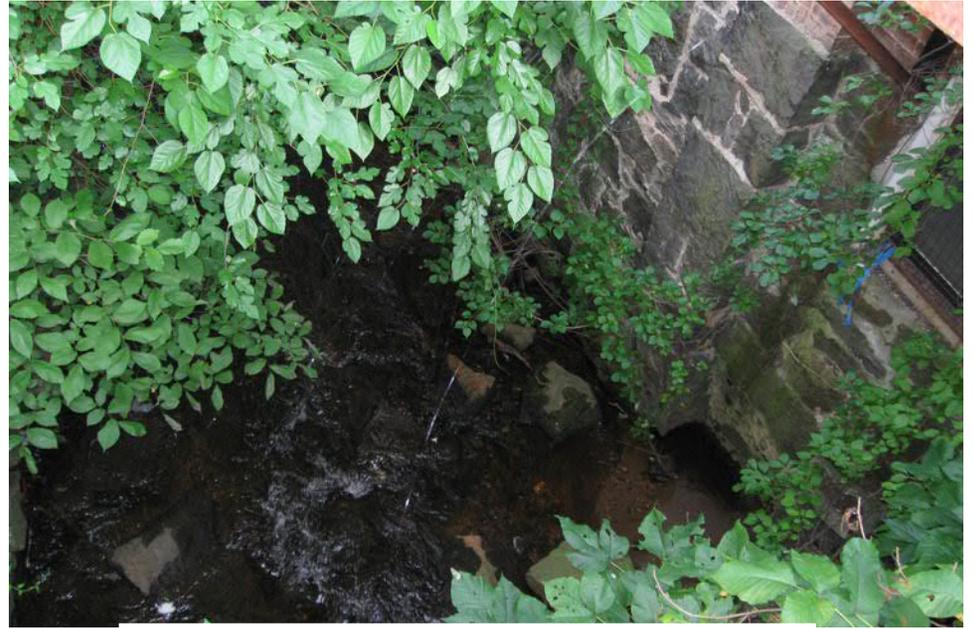
Powder Mill Brook Against Building- South Side
IMG_2719

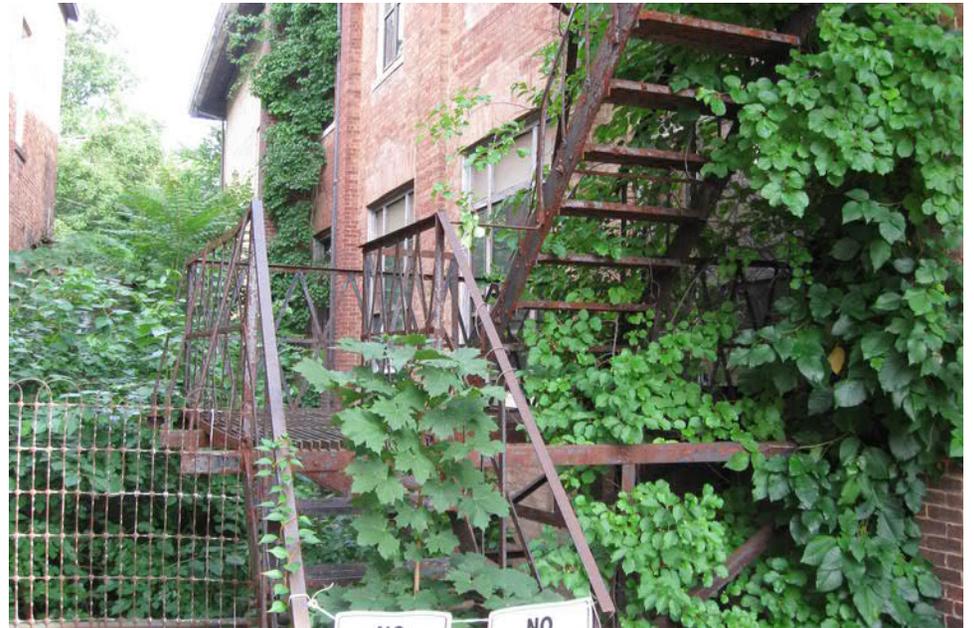
Red Soft Brick Facade - South Side
IMG_2722

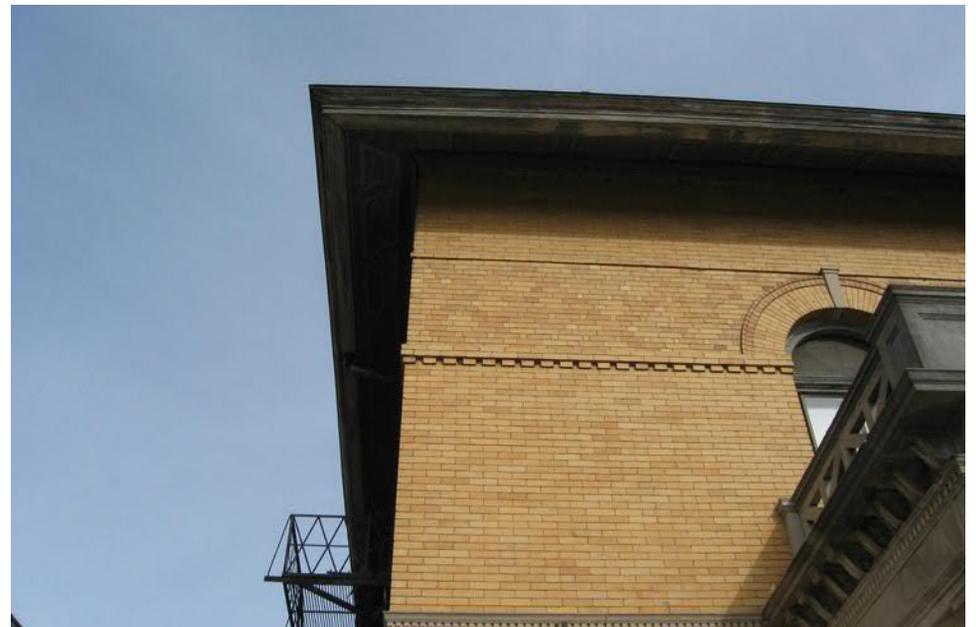
South East Corner
IMG_2726

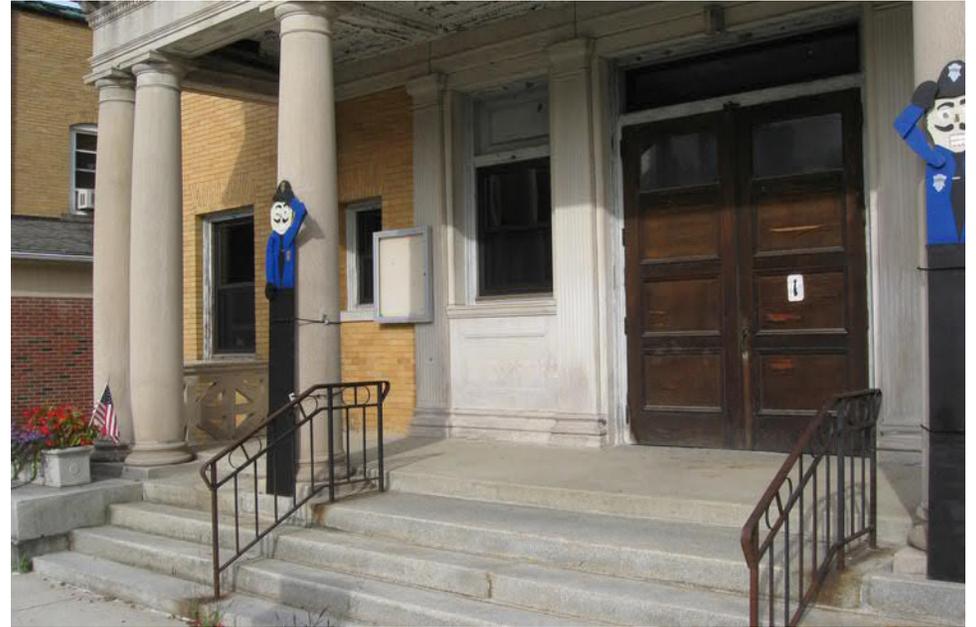
Portico - East Side
IMG_2729

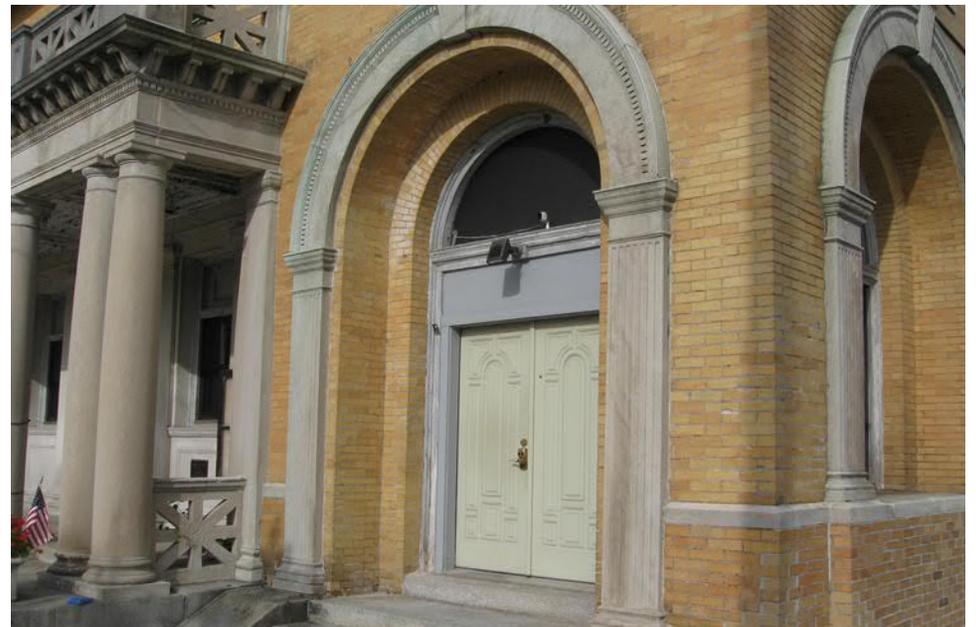
Base - Clock Tower East Side
IMG_2730

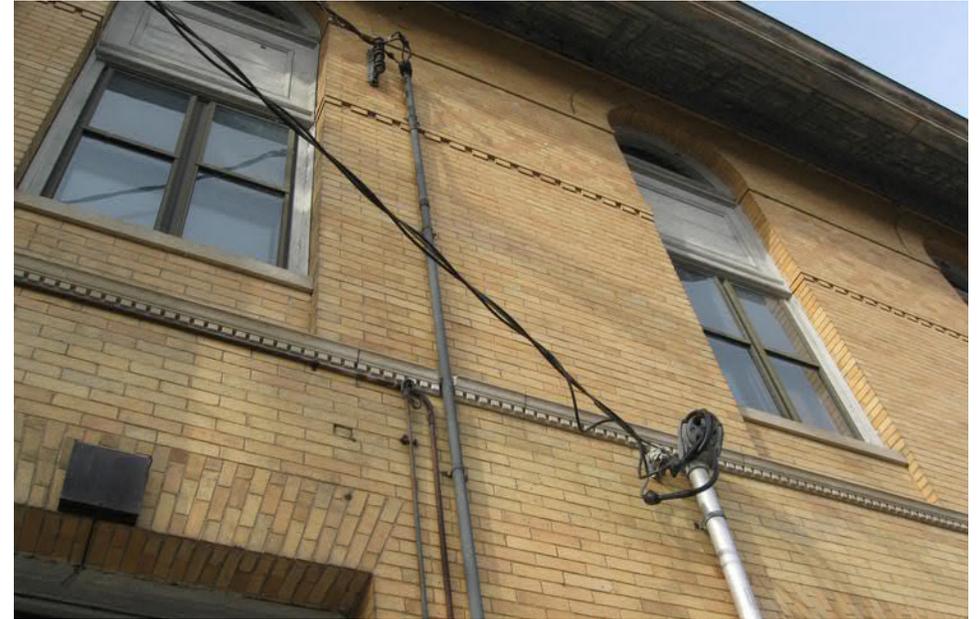
2 Electric Services - top one abandoned North (Main St - Rte 67) Side
IMG_2733

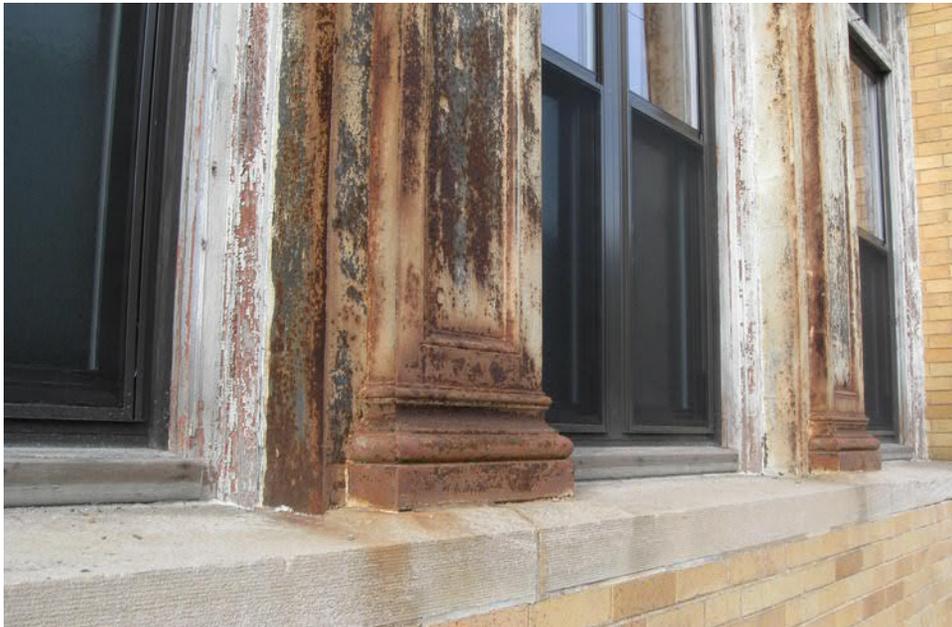
Rusted Architectural Columns - North (Main St - Rte 67)
IMG_2736

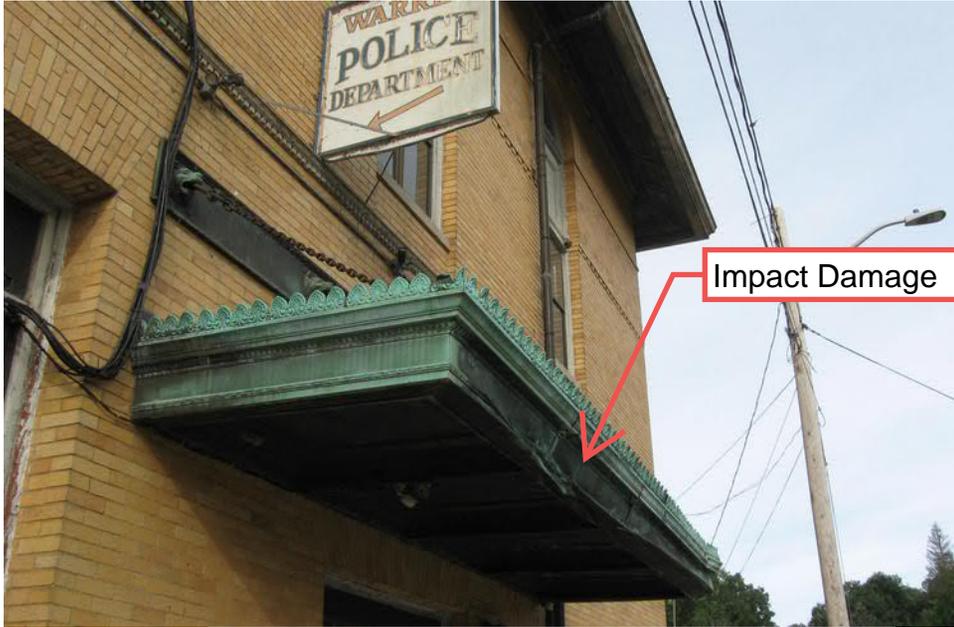
Police Entrance - North (Main St - Rte 67) Side
IMG_2739

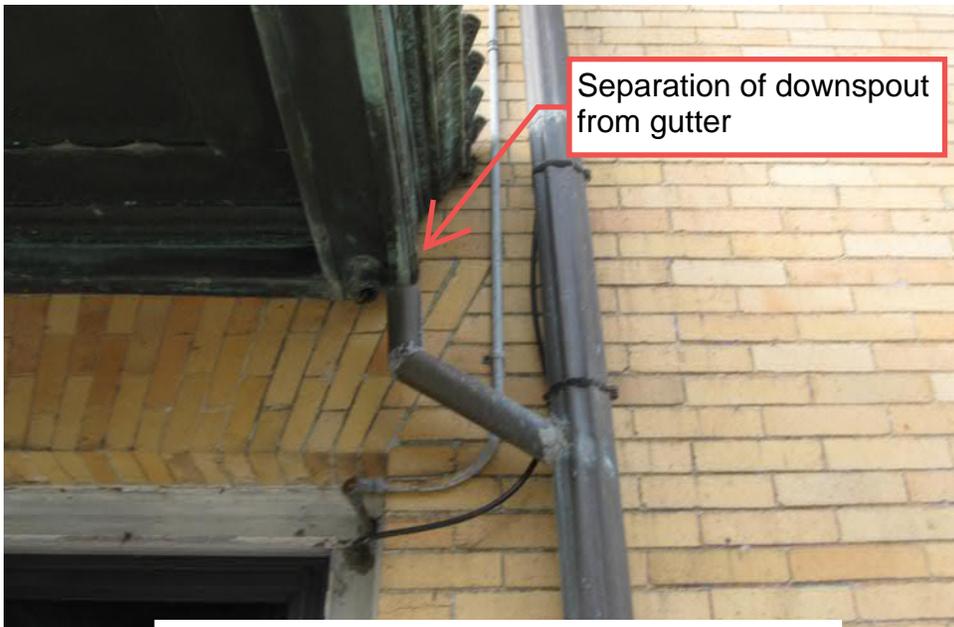
Police Entrance - North (Main St - Rte 67) Side
IMG_2740

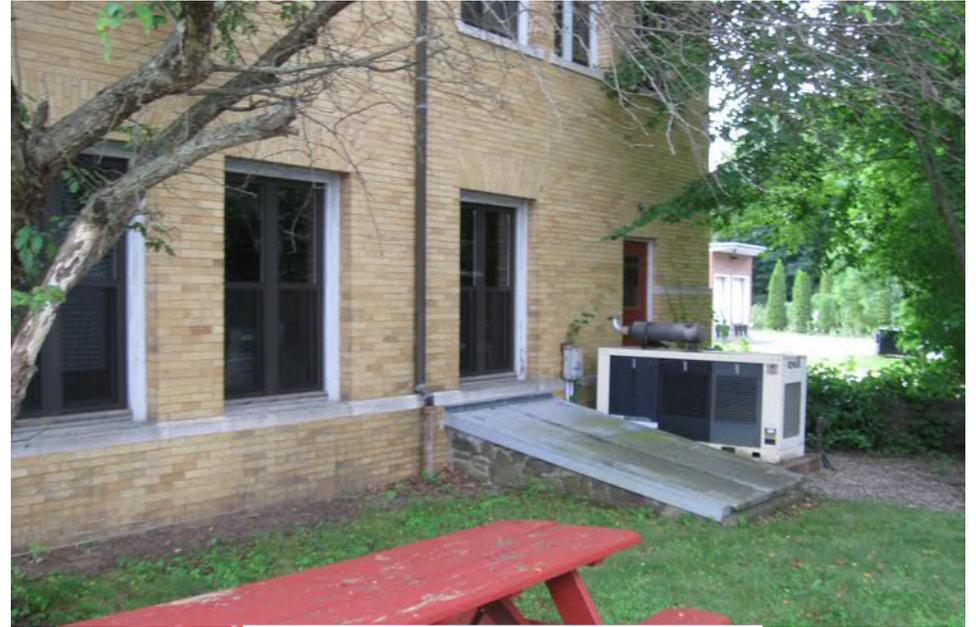
Bulkhead - Generator - West Side
IMG_2741

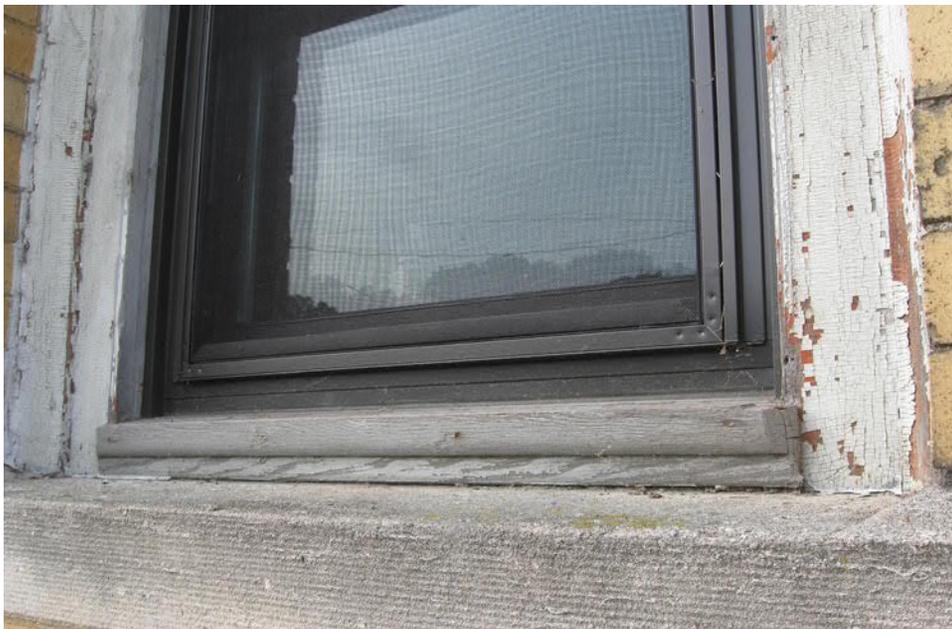
Typical Replacement Window -
Wood Head, Jambs and Sill

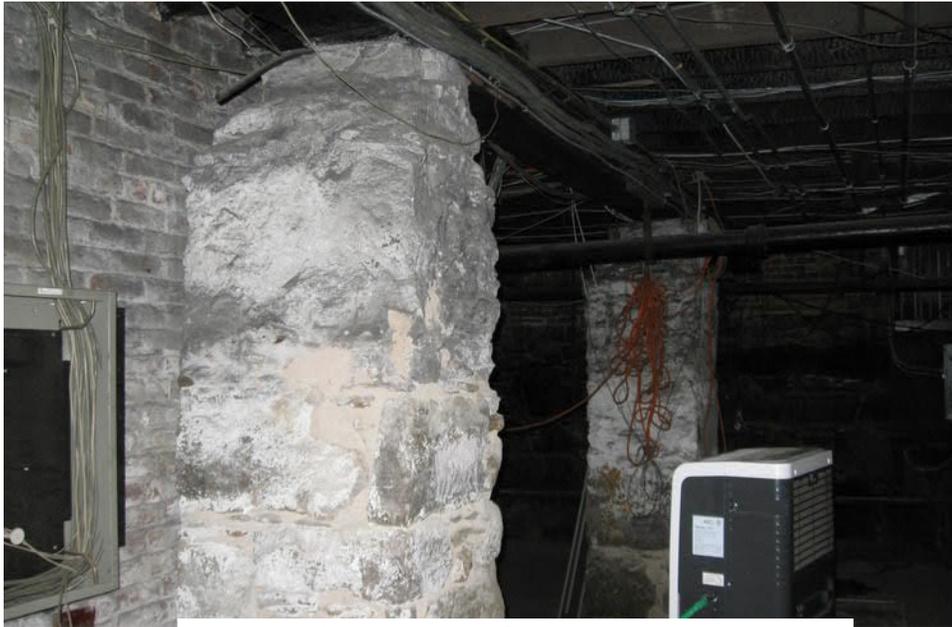
Dehumidifier - Rubble Stone and Brick Piers
IMG_2748

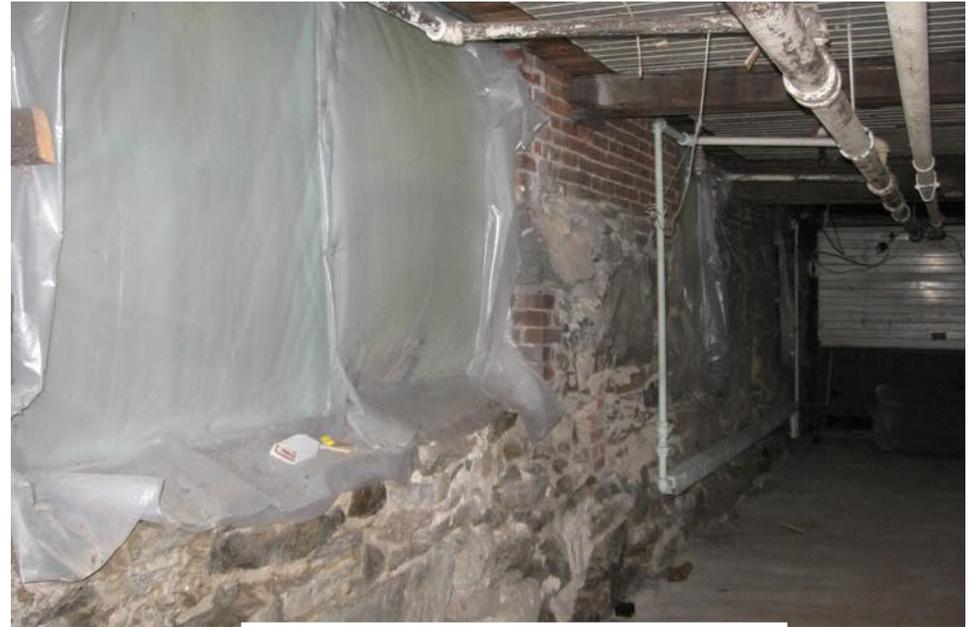
Rubble Stone and Brick Foundation
IMG_2746

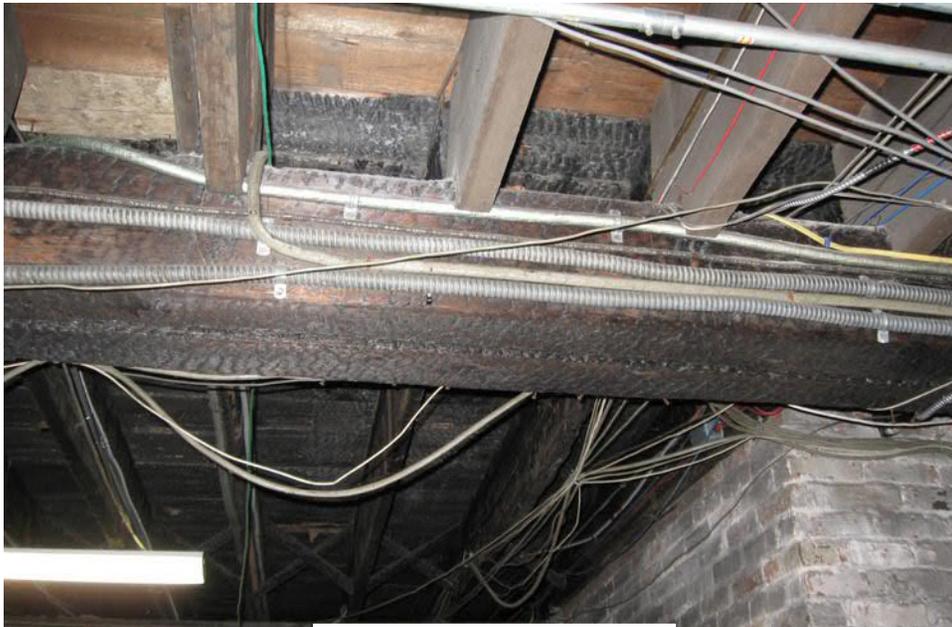
Historical Fire Damage
IMG_2749

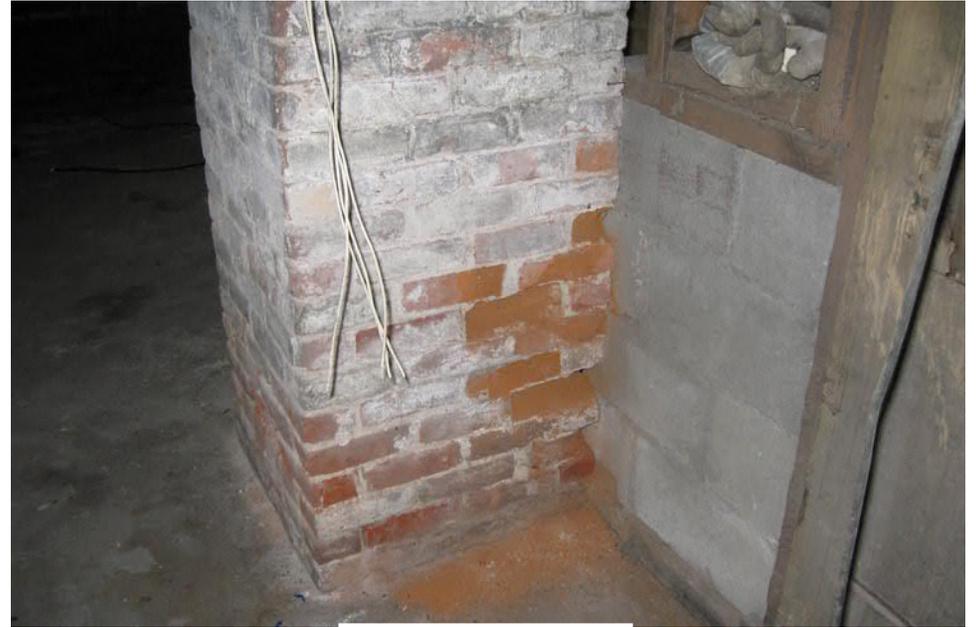
Brick Deterioration
IMG_2750

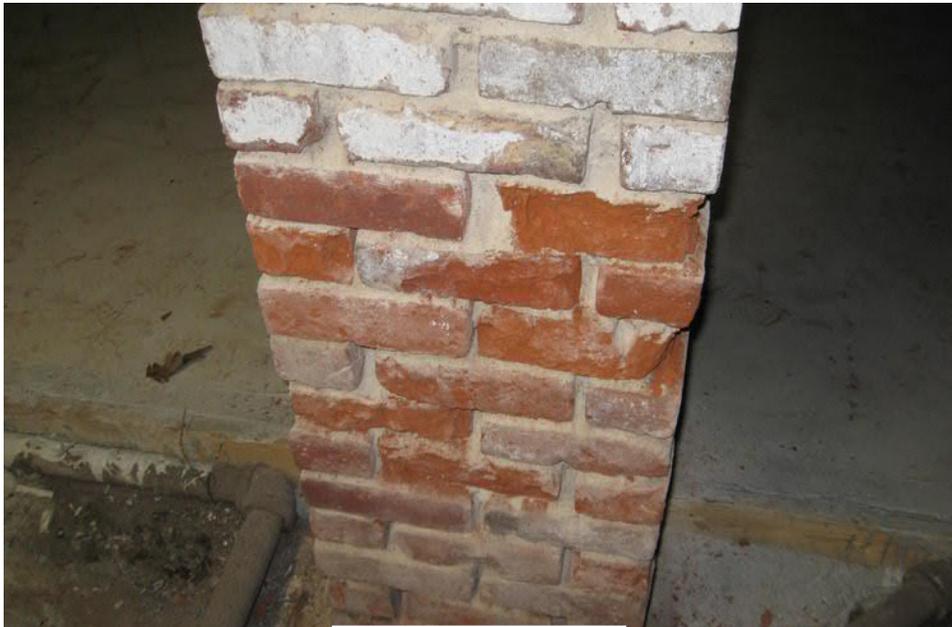
Brick Deterioration
IMG_2753

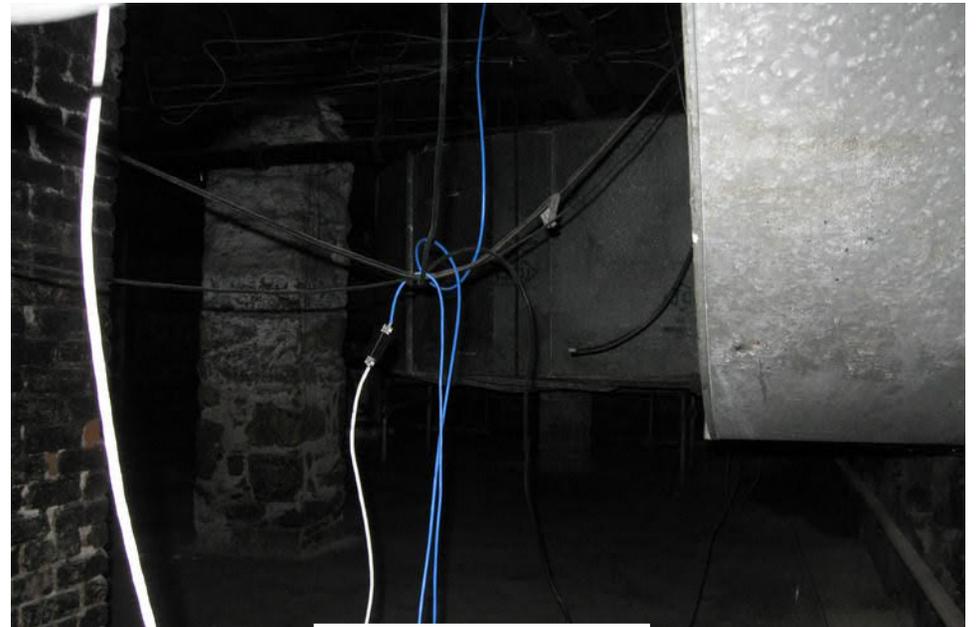
Poor Wiring Methods
IMG_2751

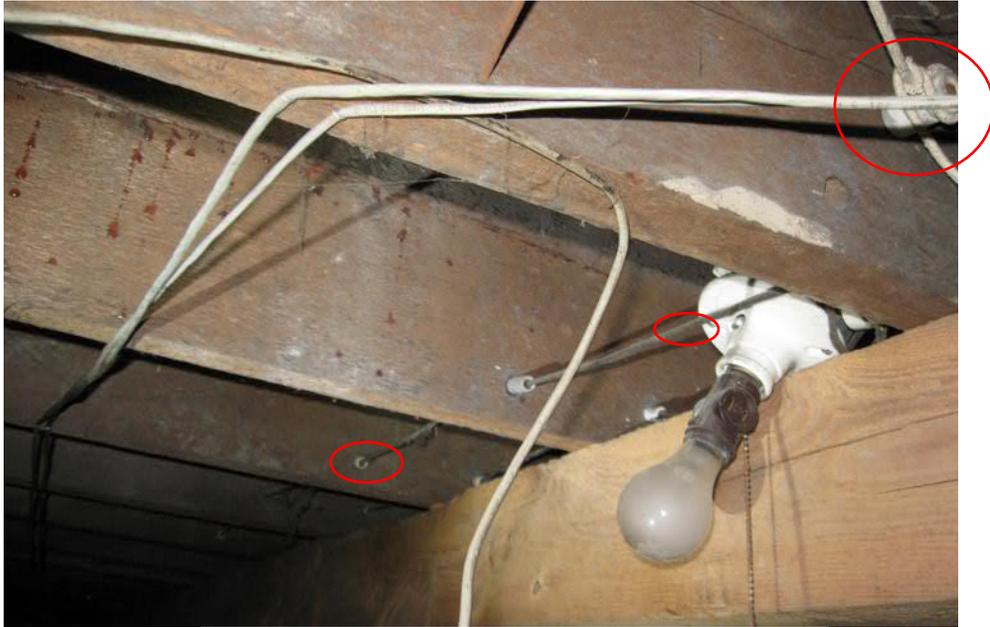
Knob & Tube Wiring - Typical Throughout
IMG_2756

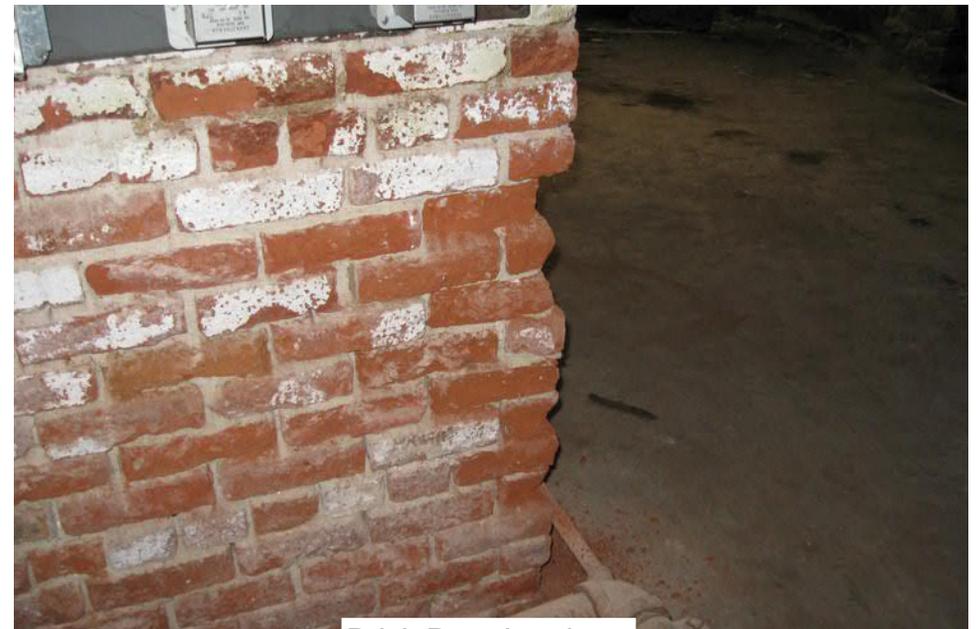
Brick Deterioration
IMG_2755

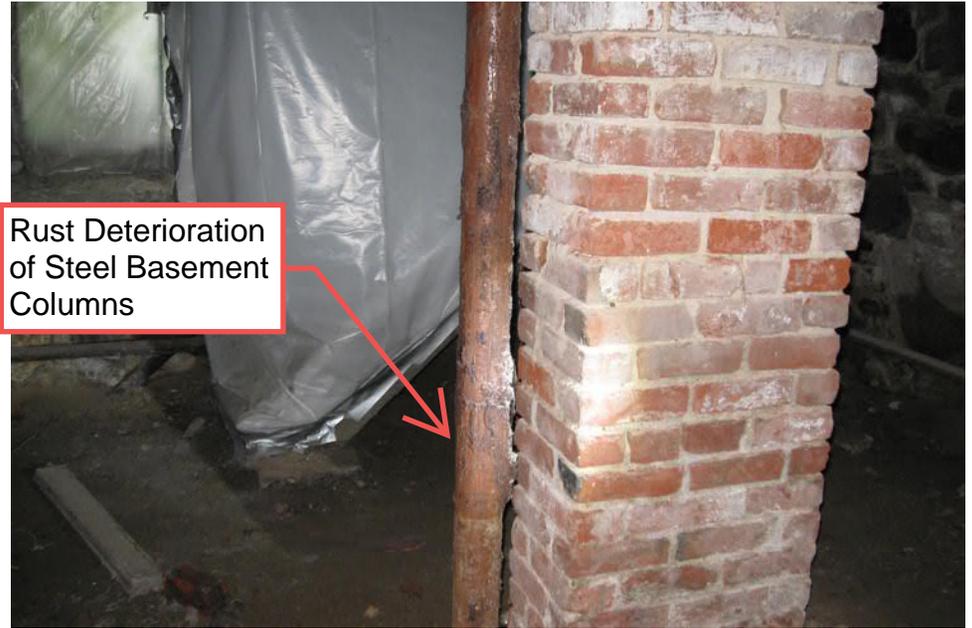
Rust Deterioration
of Steel Basement
Columns

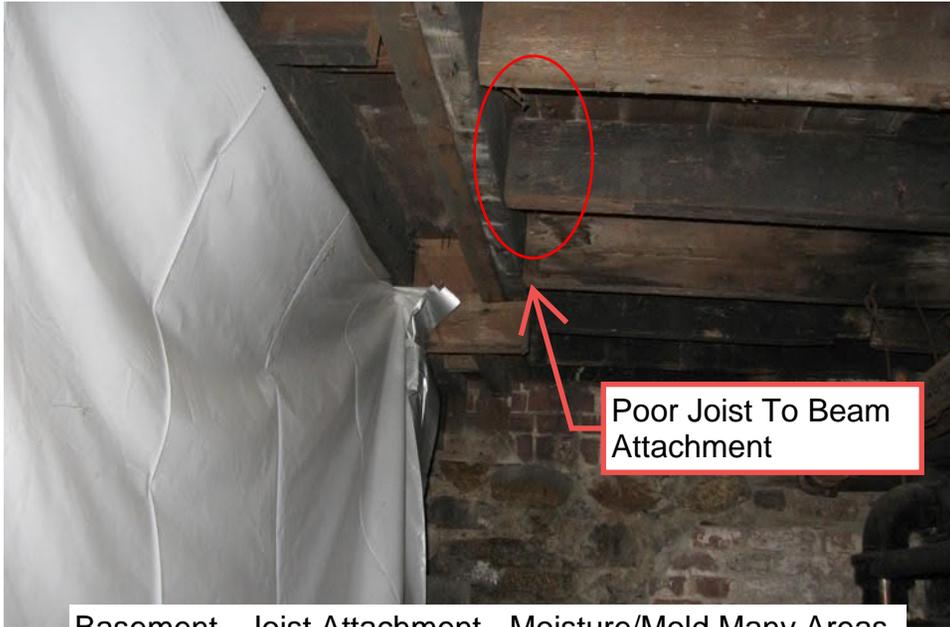
Poor Joist To Beam Attachment

Basement - Joist Attachment - Moisture/Mold Many Areas

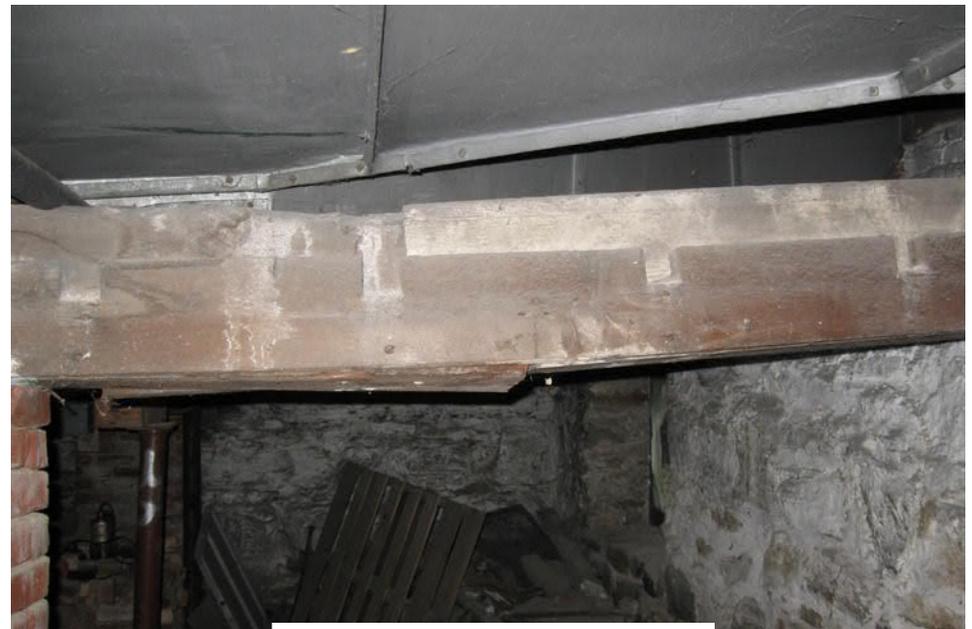
Basement - Beam Deflection

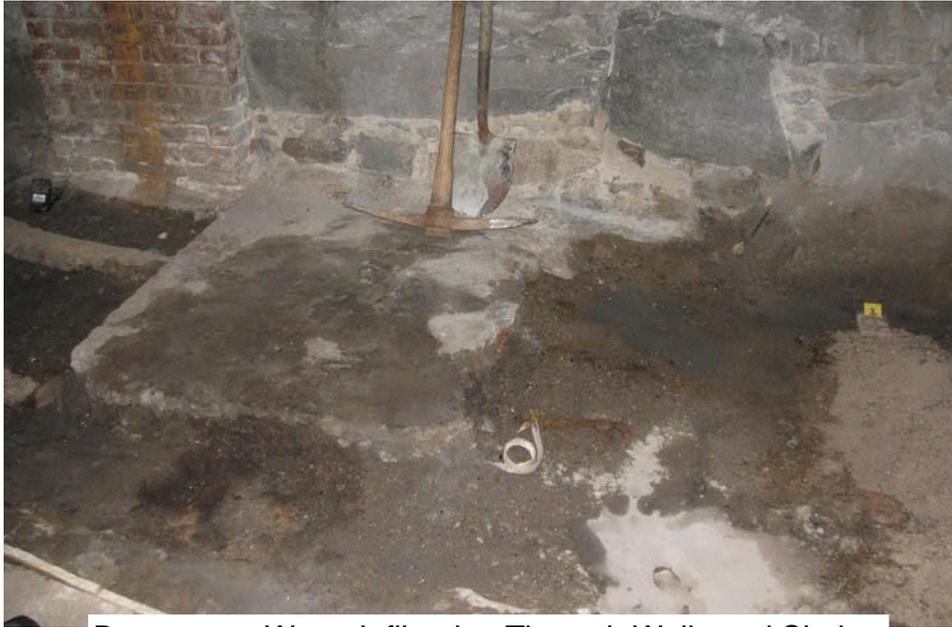
Basement - Water Infiltration Through Walls and SLab

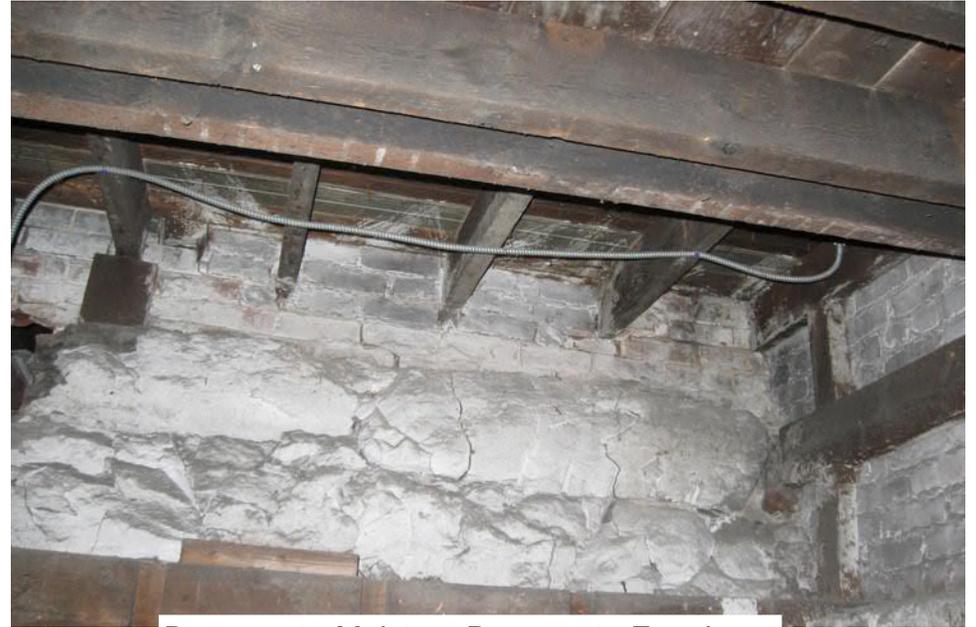
Basement - Moisture Damage to Framing

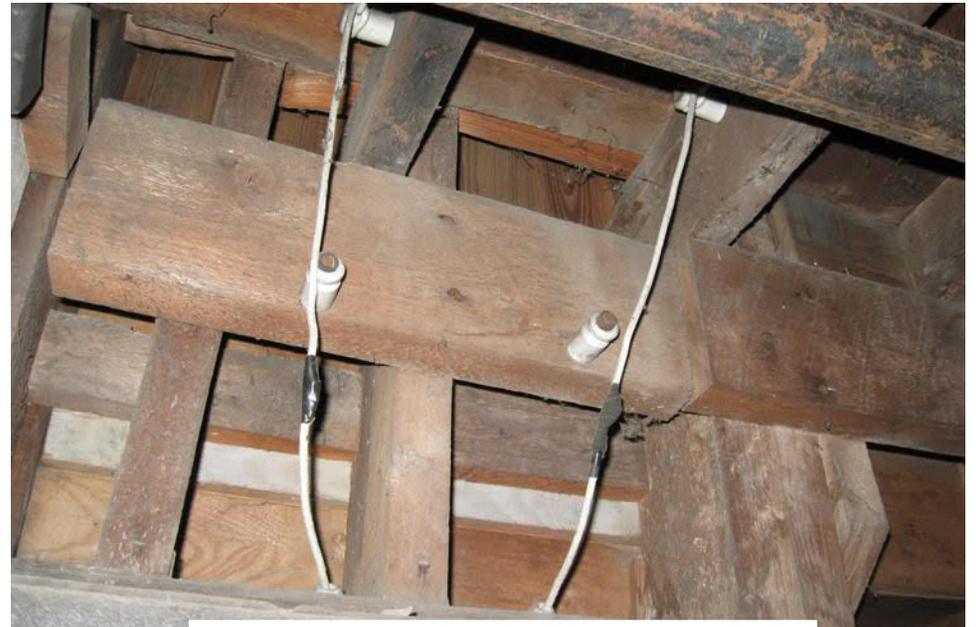
Knob & Tube Wiring - Typical Throughout

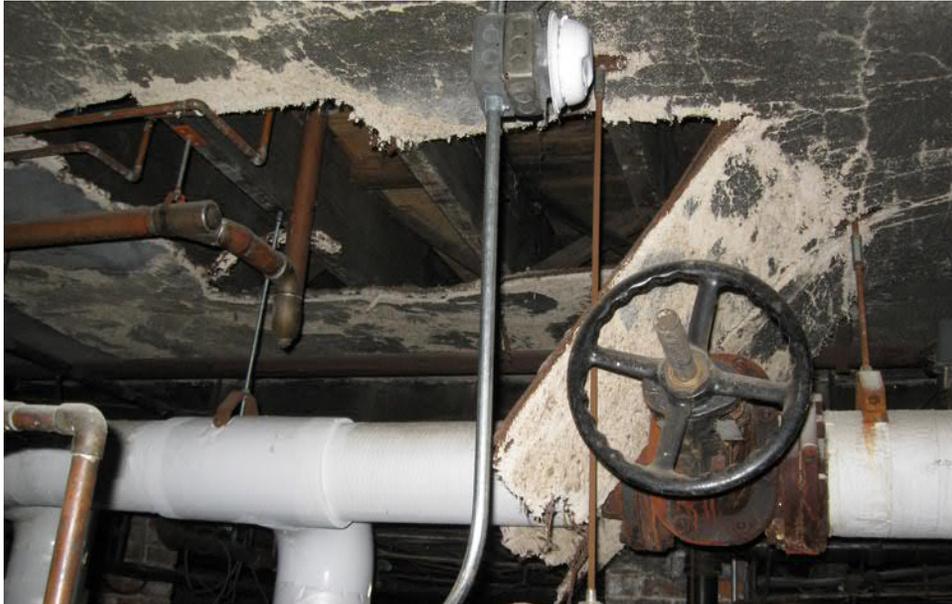
Steam Piping System - Basement - Damage to Fireproofing of Framing
IMG_2772

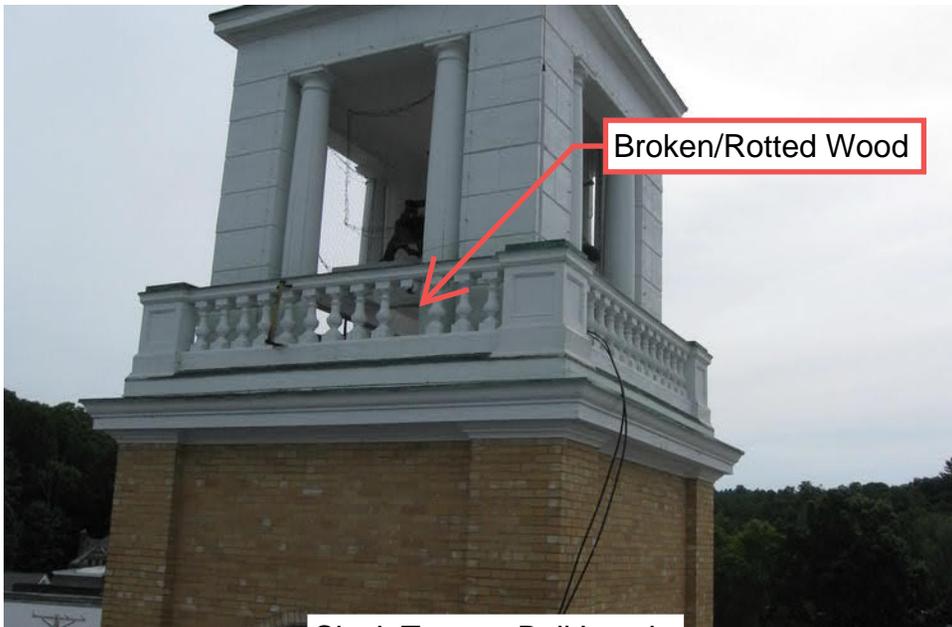
Broken/Rotted Wood

Clock Tower - Bell Level

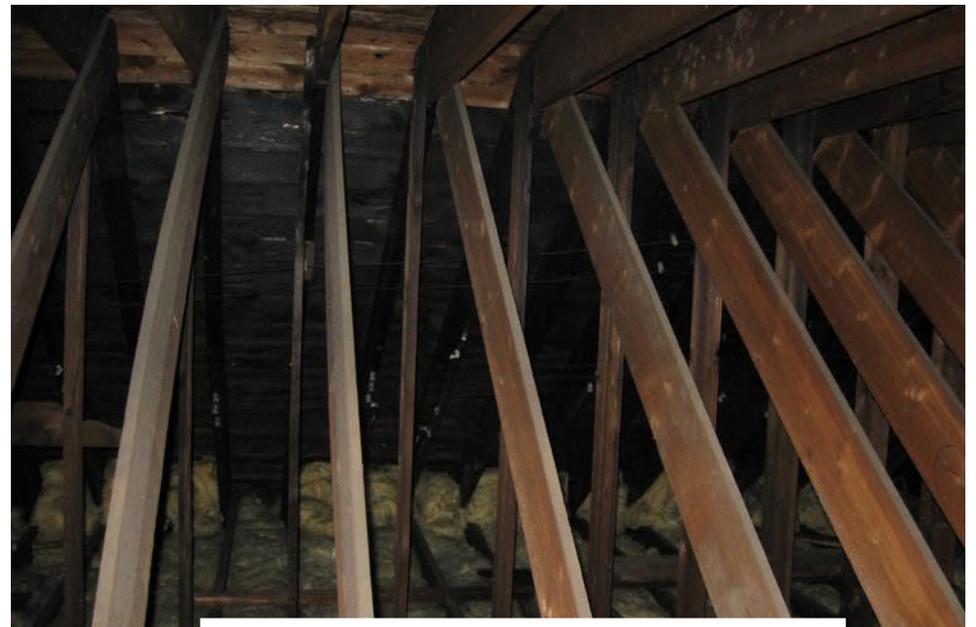
Typical Attic Framing - No Fire Protection

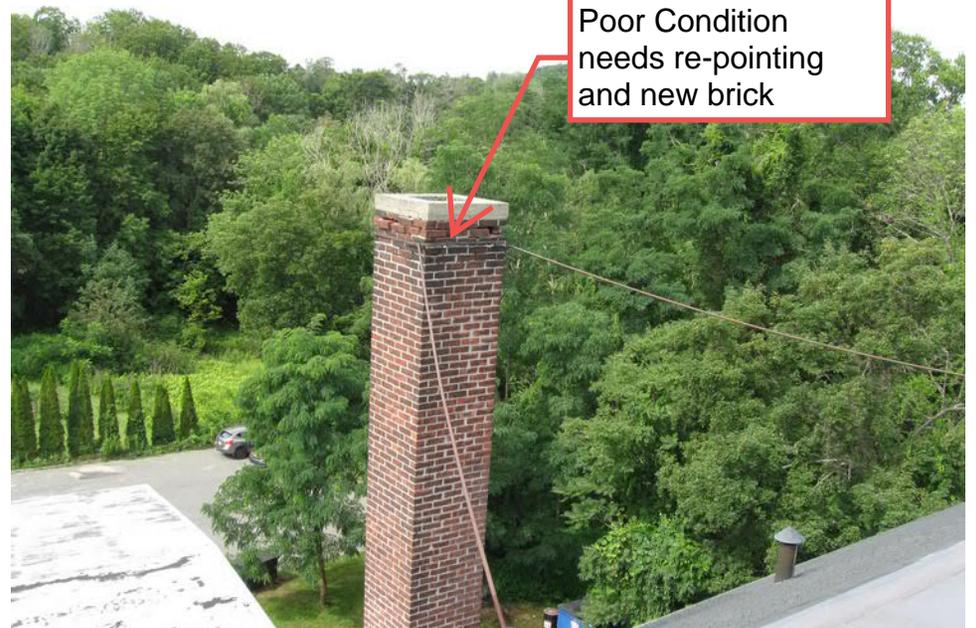
Poor Condition
needs re-pointing
and new brick

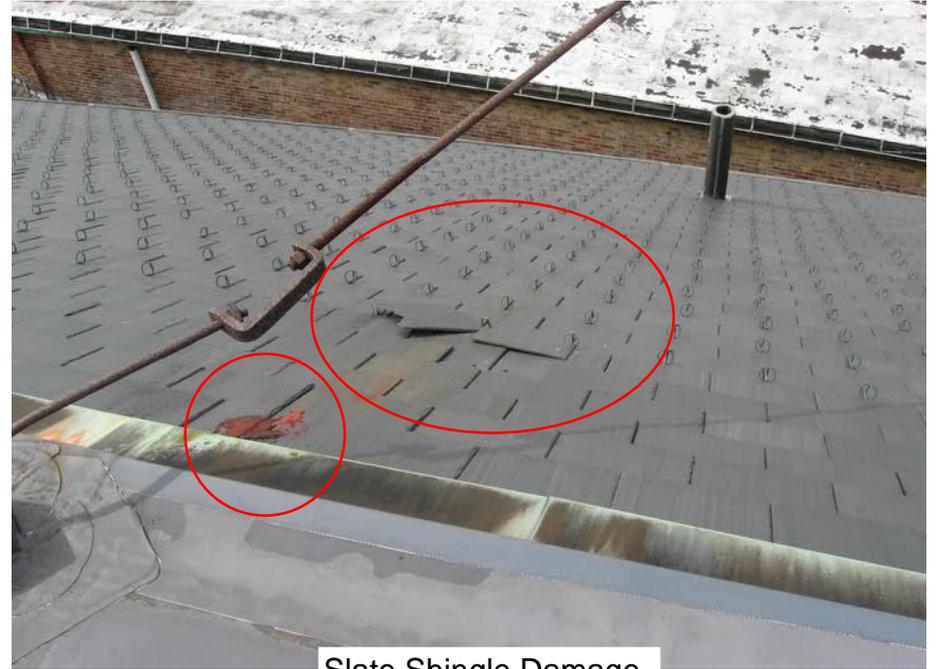
Slate Shingle Damage

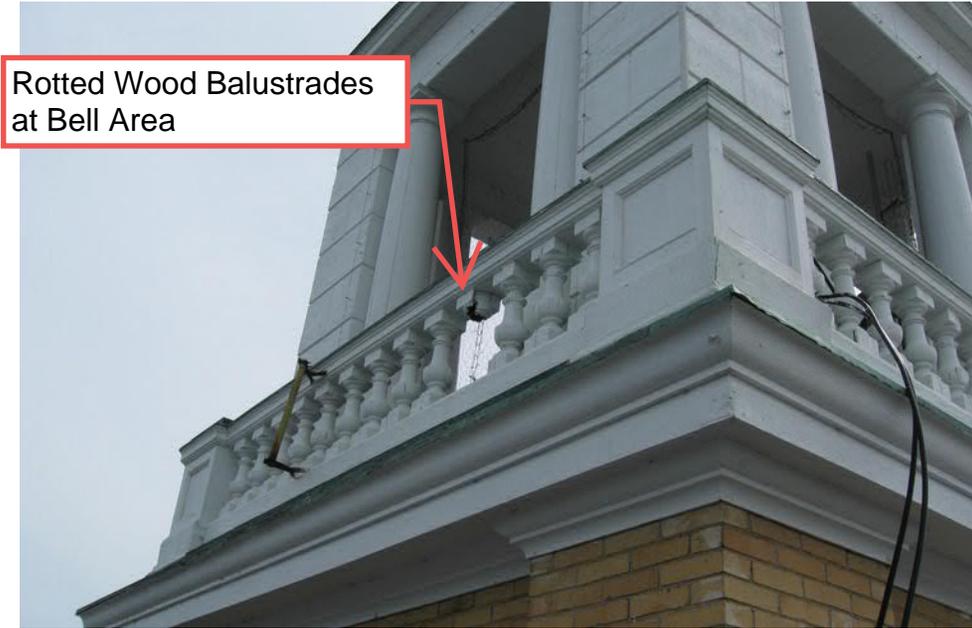
Rotted Wood Balustrades
at Bell Area

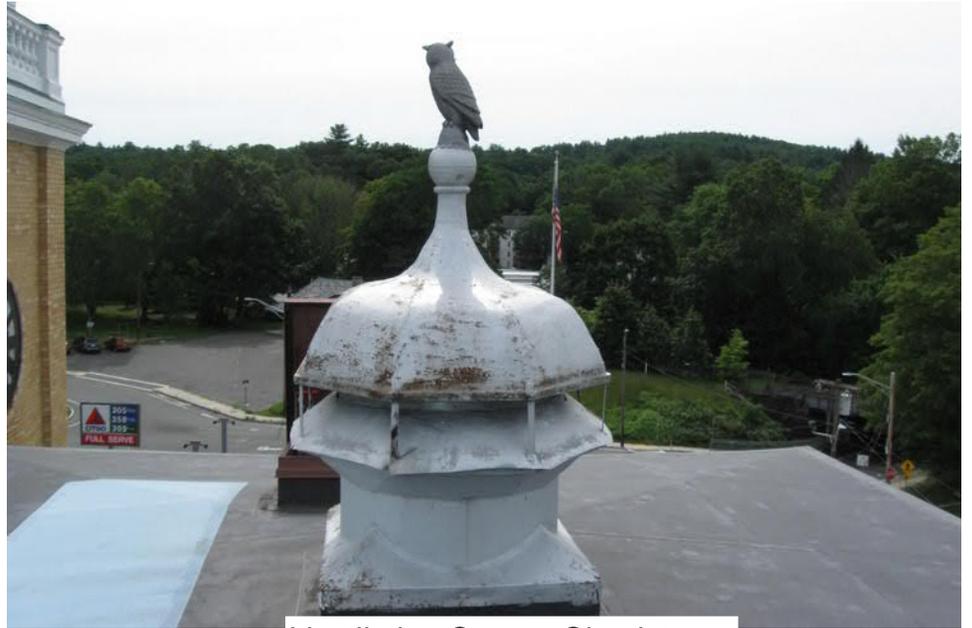
Ventilation Cover - Obsolete

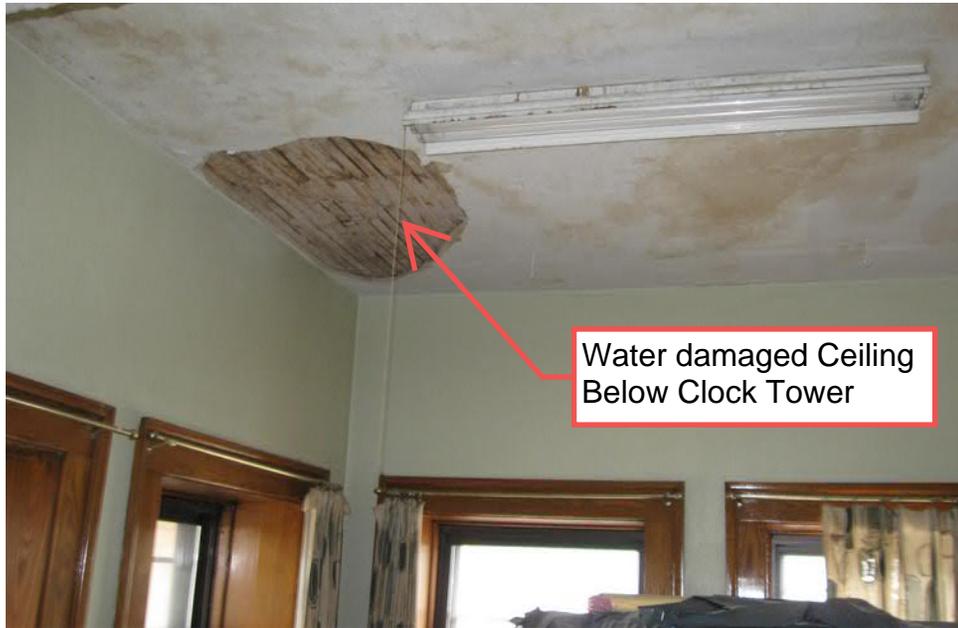
Water damaged Ceiling
Below Clock Tower

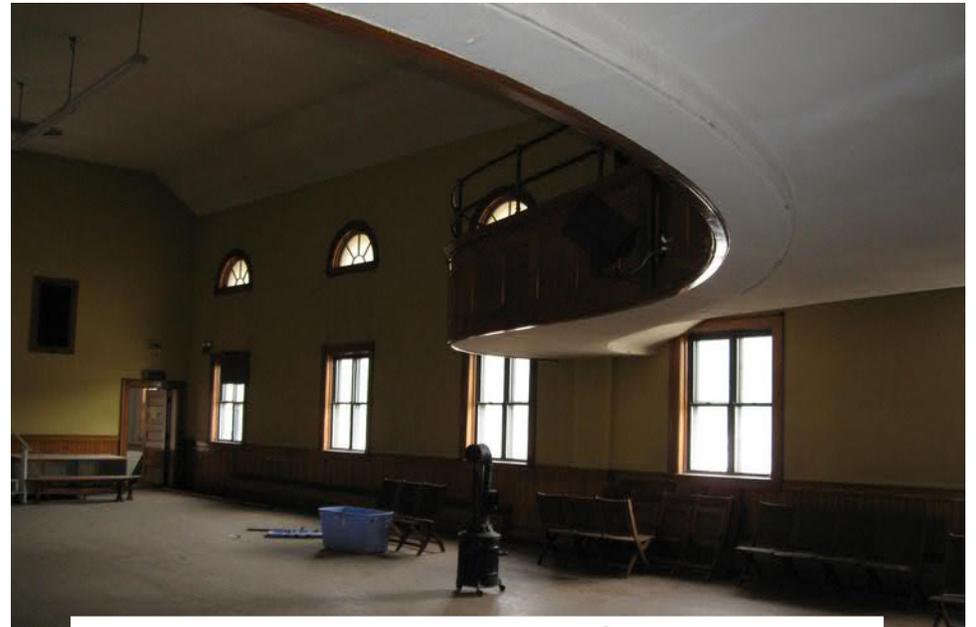
2nd Floor - Balcony Looking Toward Stage - Front Wall
IMG_2804

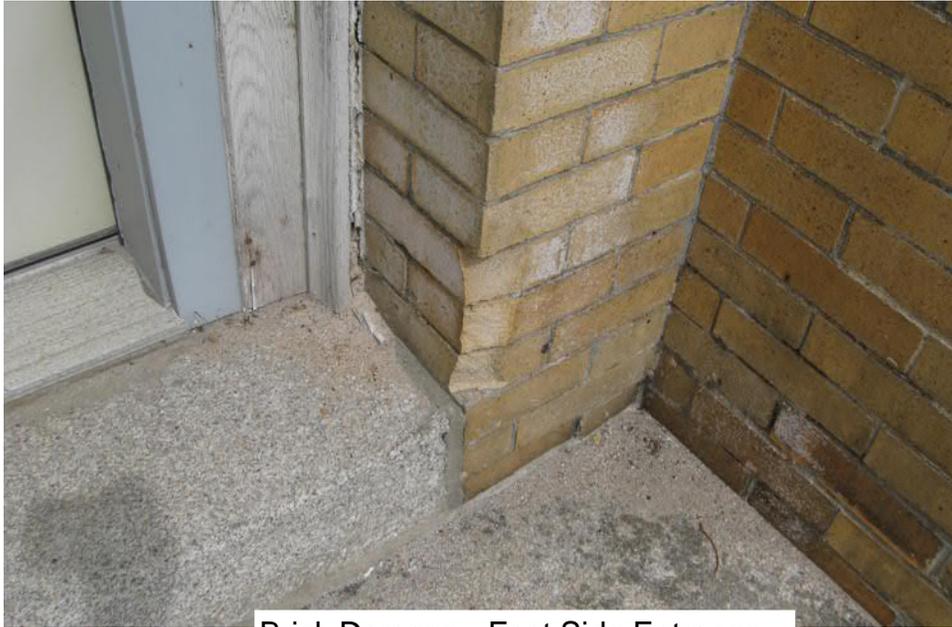
Brick Damage - East Side Entrance

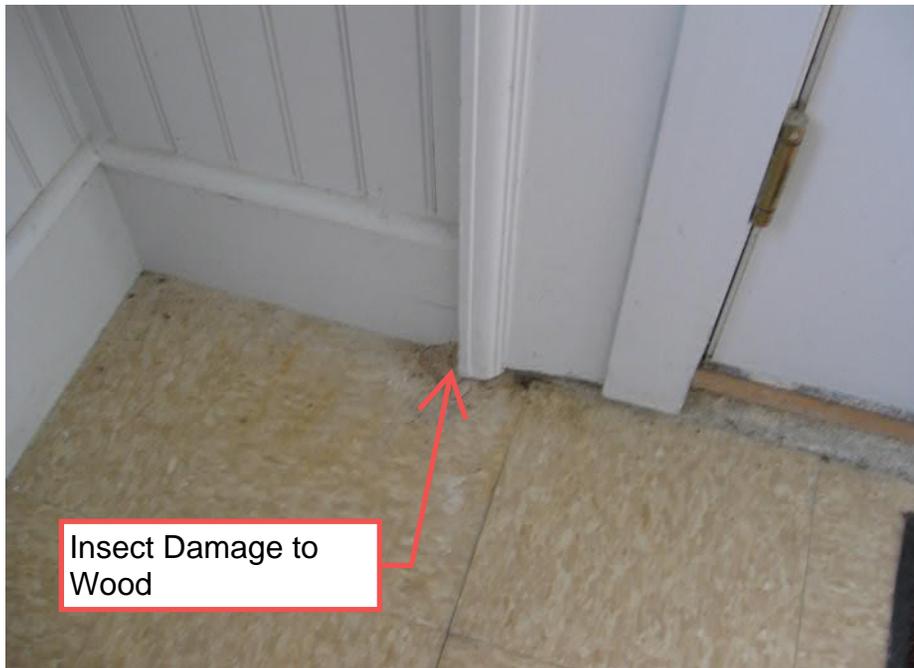
Insect Damage to Wood
